GUIDE TO ASBESTOS

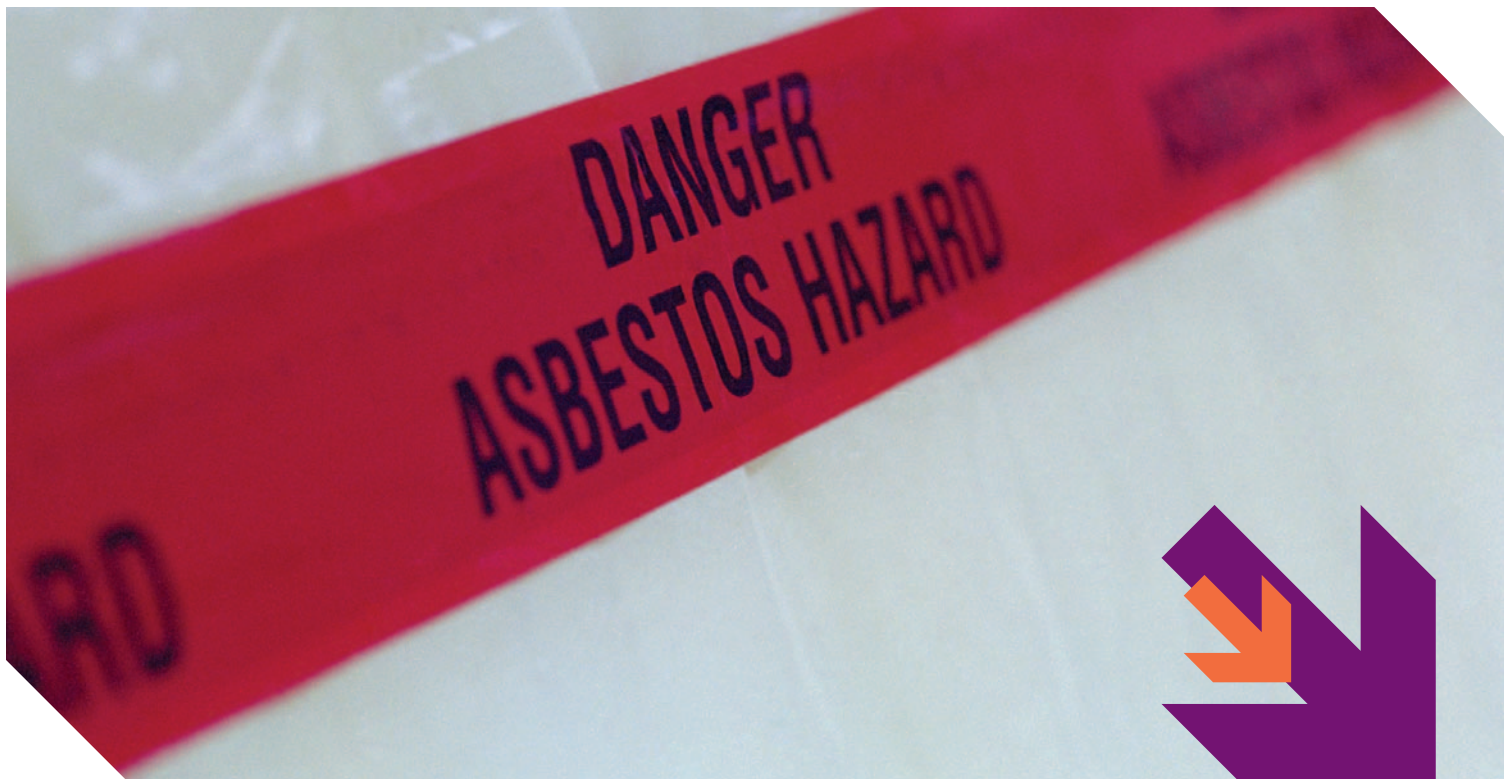
Floor tiles and WC cisterns

These items are normally manufactured from plastic with a small amount of asbestos fibre to give additional strength. This is so well bonded that it would take drilling or mechanical grinding to release the asbestos fibres. Generally they present no hazard.
